VEDANTA'S COMMITMENT TO SUSTAINABLE TAILINGS MANAGEMENT

FACT SHEET – FEBRUARY 2019

2018 PRE-AUDIT FINDINGS

BY GOLDER ASSOCIATES OF VEDANTA INDIA TMFs AND ASH PONDS

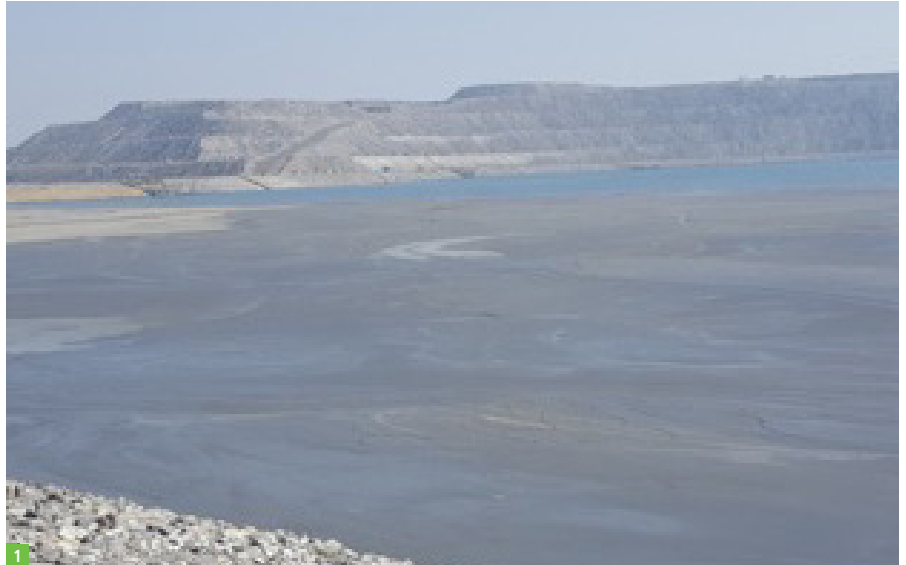
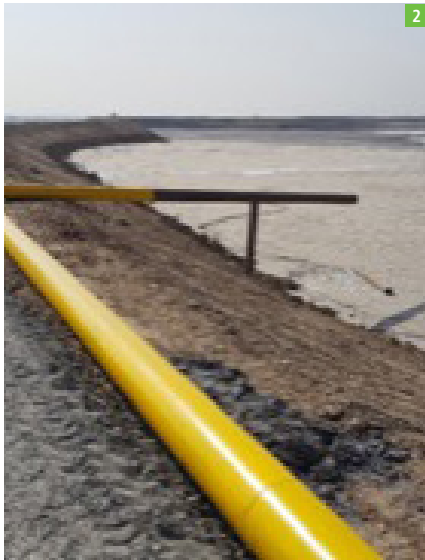
1

RAMPURA AGUCHA

- Instrumentation (piezometers and embankment settlement monuments) installed
- Addition of more discharge locations (now seven and will add two more)

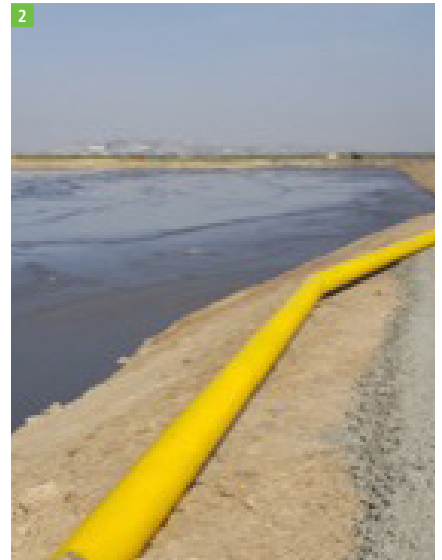
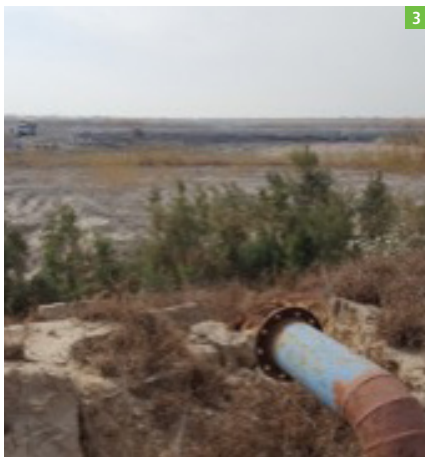
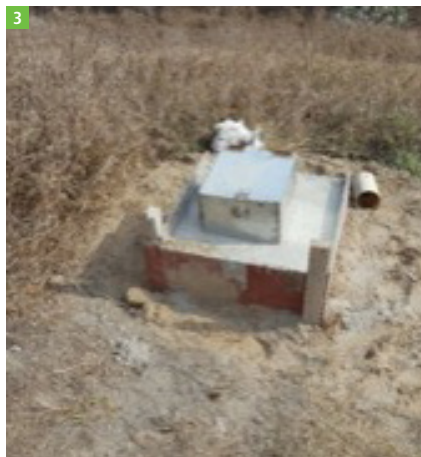
RAJPURA DARIBA COMPLEX

- Excellent freeboard and water management – construction of external return water pond
- Overall good construction quality and upgrading of tailings slurry transport and discharge lines plus starting to install piezometers (and one inclinometer) with automated data collection and web-based monitoring

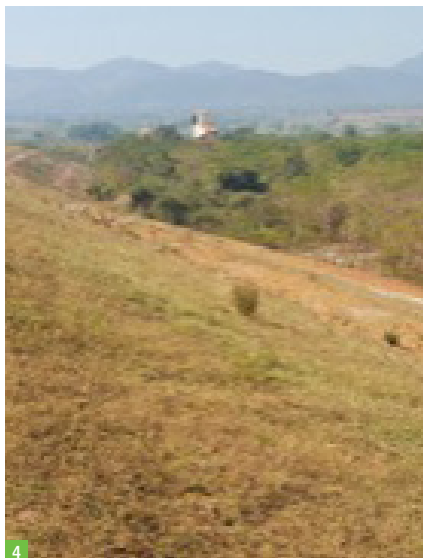
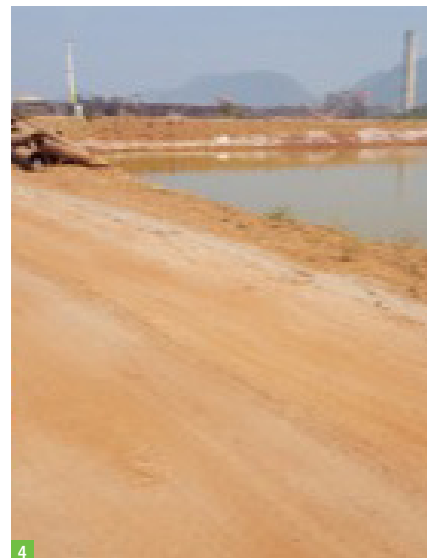
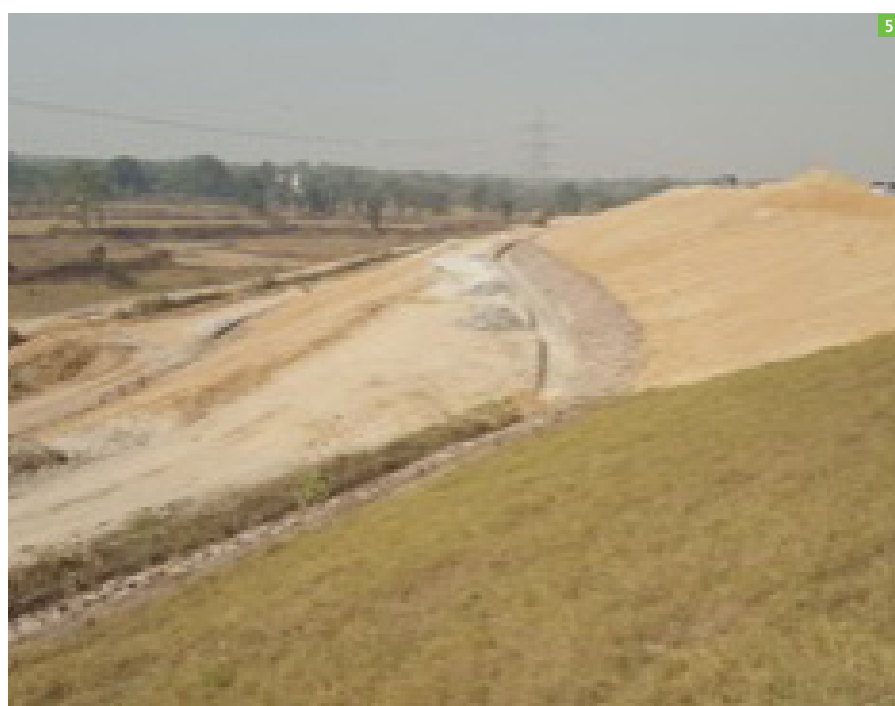
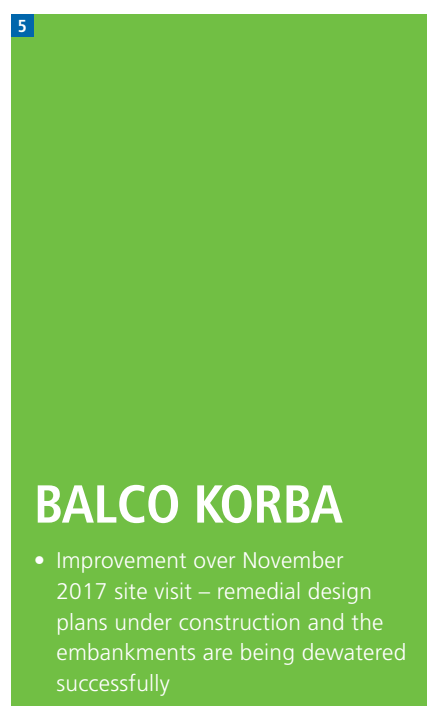
LANJIGARH

- Remedial embankment buttressing continuing
- Adequate freeboard in the West Red Mud Pond (water storage pond that decants to the Process Water Lake)

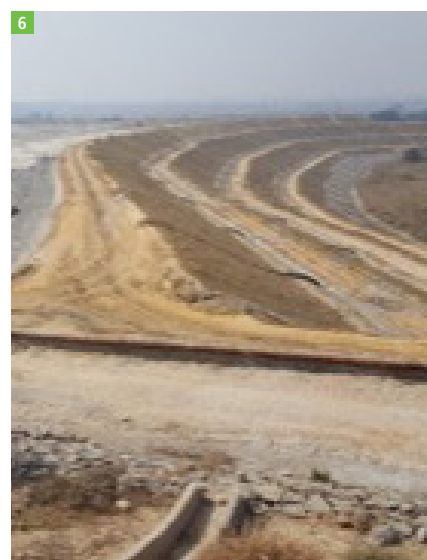
JHARSUGUDA

- Excellent documentation, quality remedial construction, and overall ash management. Lagoon 3, shown left with multiple deposition points from perimeter slurry line
- Successful rehabilitation and raising of Pond 1 is a testimony to the Jharsuguda Ash Team's efforts in stabilizing Lagoon 1 and developing capacity for future ash storage
