VEDANTA'S COMMITMENT TO SUSTAINABLE TAILINGS MANAGEMENT

FACT SHEET – FEBRUARY 2019

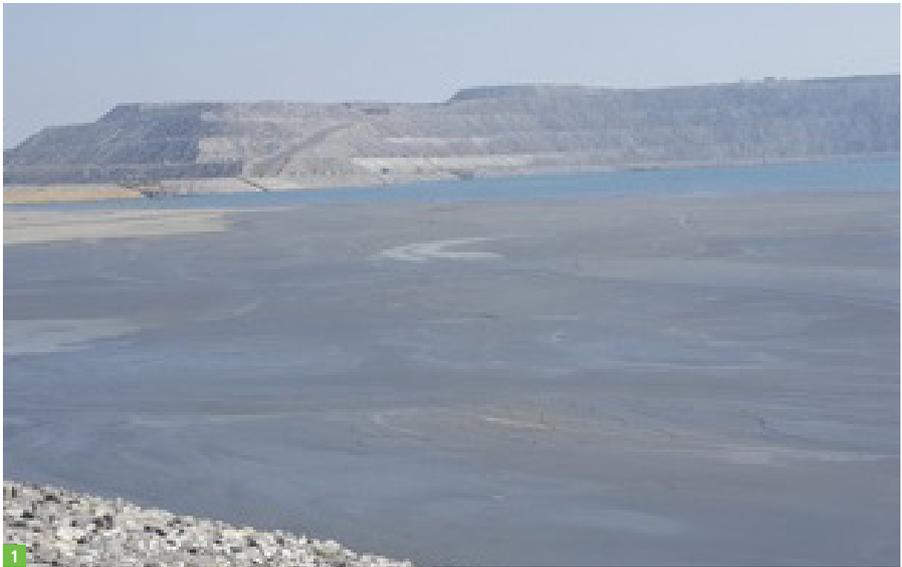
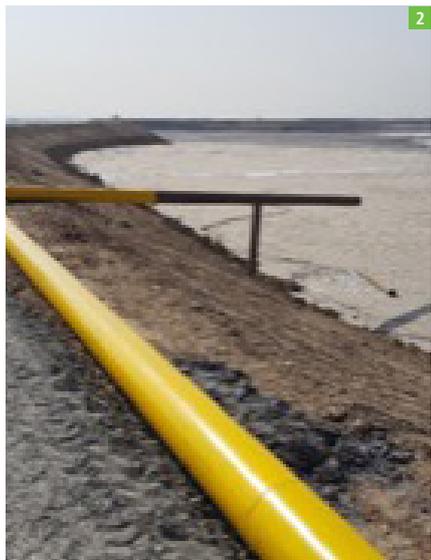
RAMPURA AGUCHA

- Instrumentation (piezometers and embankment settlement monuments) installed
- Addition of more discharge locations (now seven and will add two more)

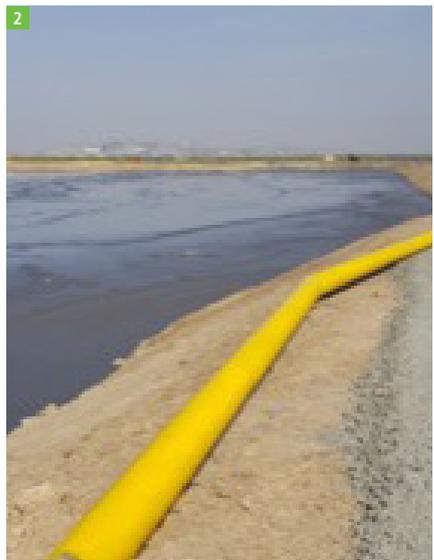
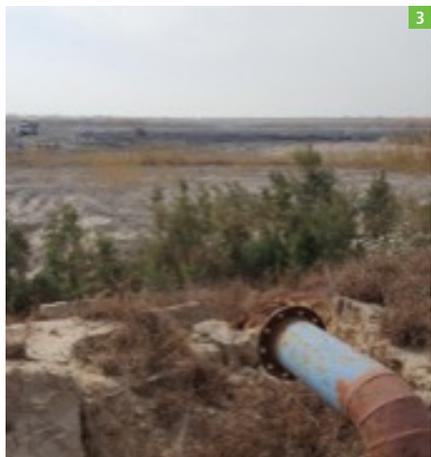
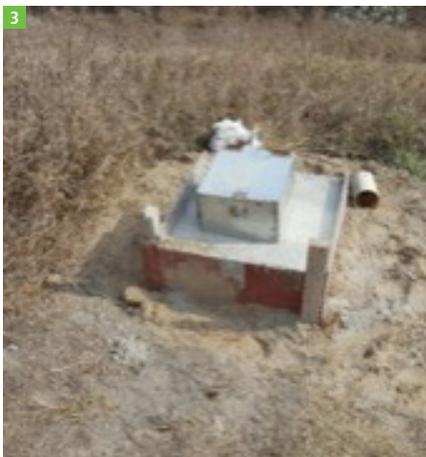
RAJPURA DARIBA COMPLEX

- Excellent freeboard and water management – construction of external return water pond
- Overall good construction quality and upgrading of tailings slurry transport and discharge lines plus starting to install piezometers (and one inclinometer) with automated data collection and web-based monitoring

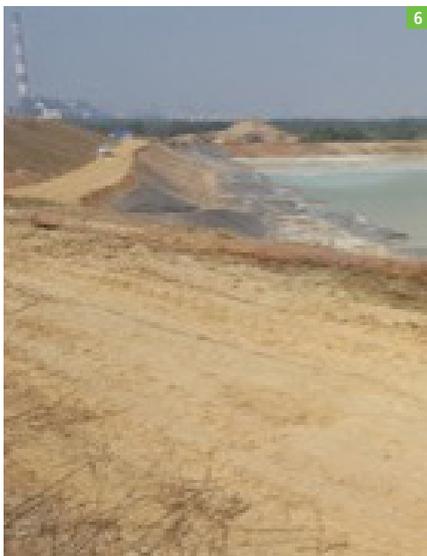
BALCO KORBA

- Improvement over November 2017 site visit – remedial design plans under construction and the embankments are being dewatered successfully

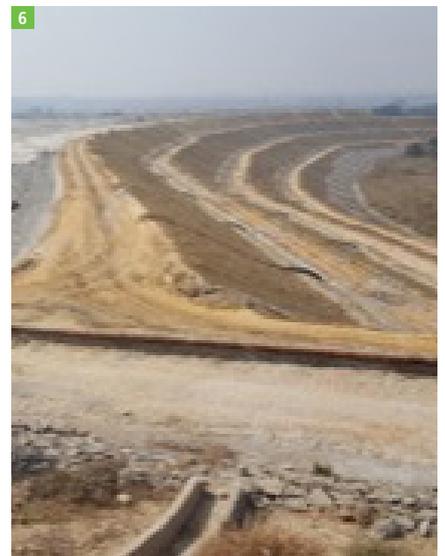
JHARSUGUDA

- Excellent documentation, quality remedial construction, and overall ash management. Lagoon 3, shown left with multiple deposition points from perimeter slurry line
- Successful rehabilitation and raising of Pond 1 is a testimony to the Jharsuguda Ash Team's efforts in stabilizing Lagoon 1 and developing capacity for future ash storage

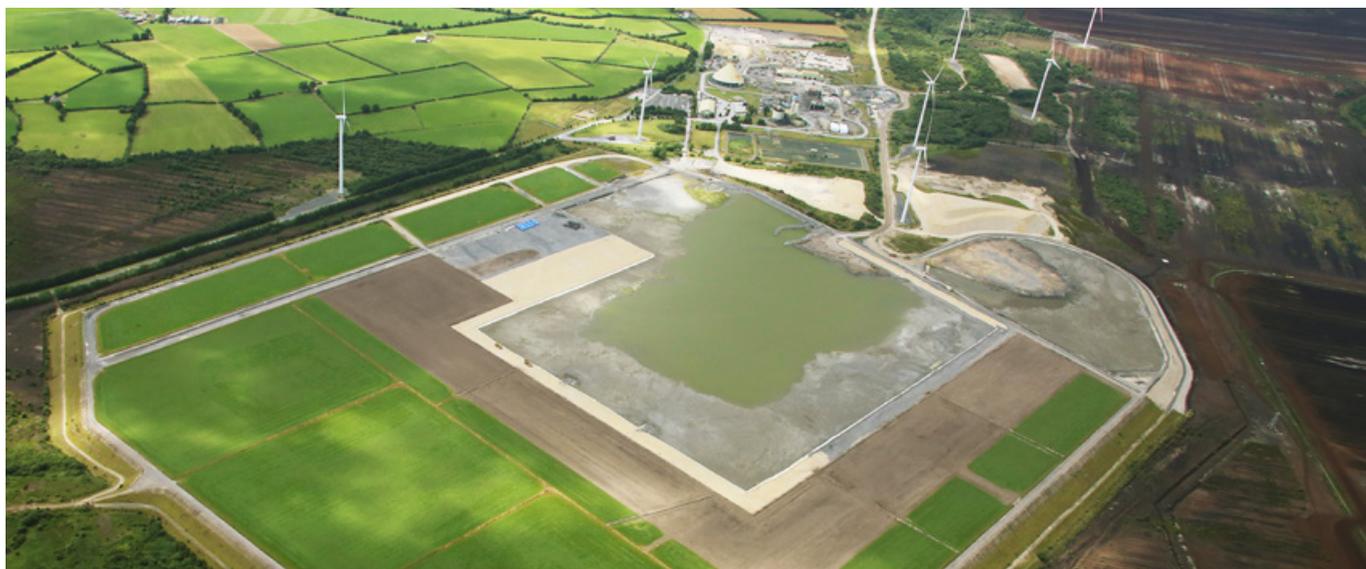
Lisheen, Ireland

Lisheen Mine started a progressive rehabilitation programme in the early 2000s as part of its Closure, Rehabilitation & Aftercare Management Plan (CRAMP) which was fully approved by all regulatory authorities. The TMF rehabilitation works consisted of a 1m thick hybrid cap being placed over the tailings, with each element of the cap fulfilling a specific function. The first layer was a geotextile, followed by 700mm of limestone rock and then 300 to 400mm of soil, covered with grass to form a stable and sustainable surface. A system of spillways was installed to manage water on the facility. A certain amount of water is maintained within the rock cap, just above the elevation of the tailings, to make sure they are kept moist and will not oxidise to produce acid mine drainage.
